The Decommissioning of DRES Building 12

July 1997

SUFFIELD REPORT No. 655

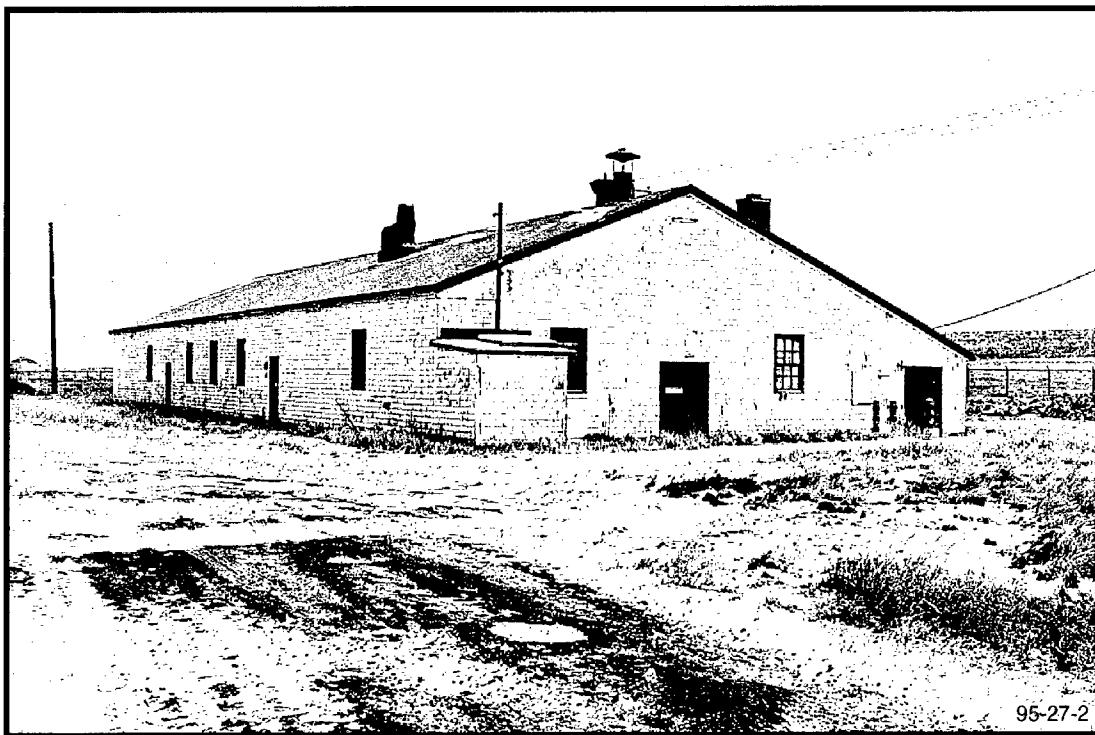
Figure 2. Building 12 Exterior View

Building 12 was located within a secure, fenced compound in the CFB Suffield Magazine Area, approximately 1 km north of the main Base Administration Area along Jenner Road (see Figure 1). The building, shown in Figure 2, was of wood-frame construction with dimensions 50 m x 10 m x 4 m. The building was erected during World War II to provide cover for five concrete vaults located partially below ground (see Figure 3). Each vault had dimensions 9 m x 6 m x 4 m with a wall thickness of 25 - 35 cm. As shown by the example in Figure 4, the vaults were fully lined internally with lead sheet, approximately 6.5 mm thick. Two vaults were combined to provide space for the operation of a laboratory facility (R/A Laboratory), as shown in Figures 5 and 6. All vaults, except one central vault, were modified to allow access by stairway from ground level. The building was supplied with electrical, water and natural gas utilities.

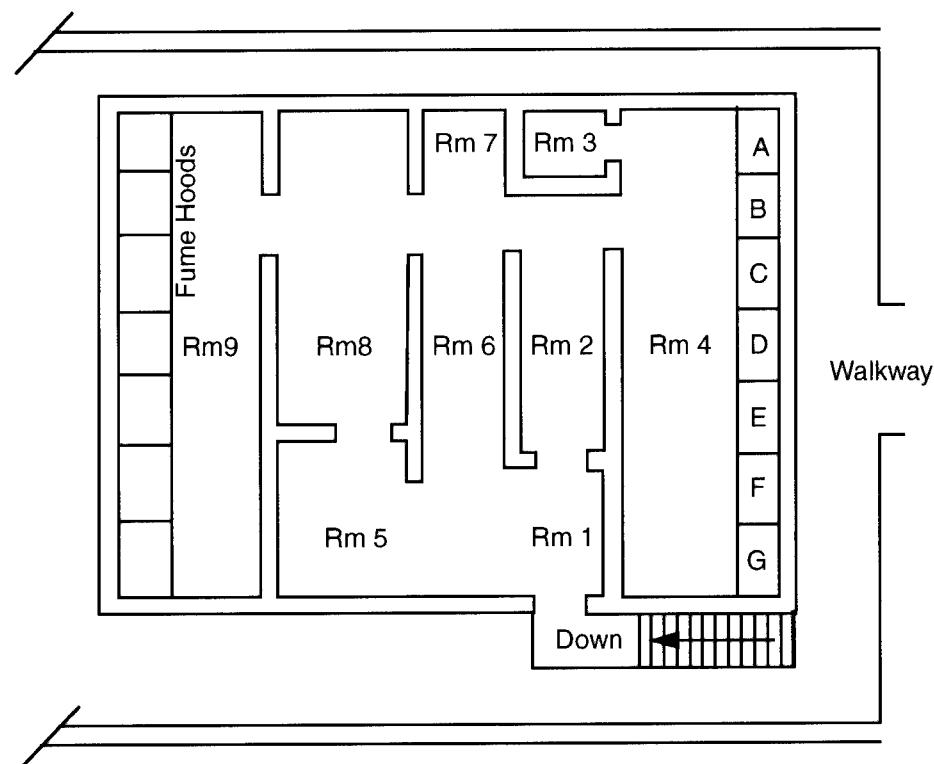
Figure 7. R/A Laboratory Schematic

In the early 1950s, a laboratory was constructed within the southernmost two vaults (Vaults #4 and #5) of Building 12. This facility, known as the Radioactive Synthesis and Analysis (R/A) Laboratory, was equipped with fume hoods (14 total) as well as sinks, storage shelves and personnel decontamination areas. The laboratory was divided into three main areas, *viz*: a radioactive agent synthesis area, a central 'dry box' sample preparation and work area, and an agent simulant preparation area. A schematic of the laboratory is shown in Figure 7.

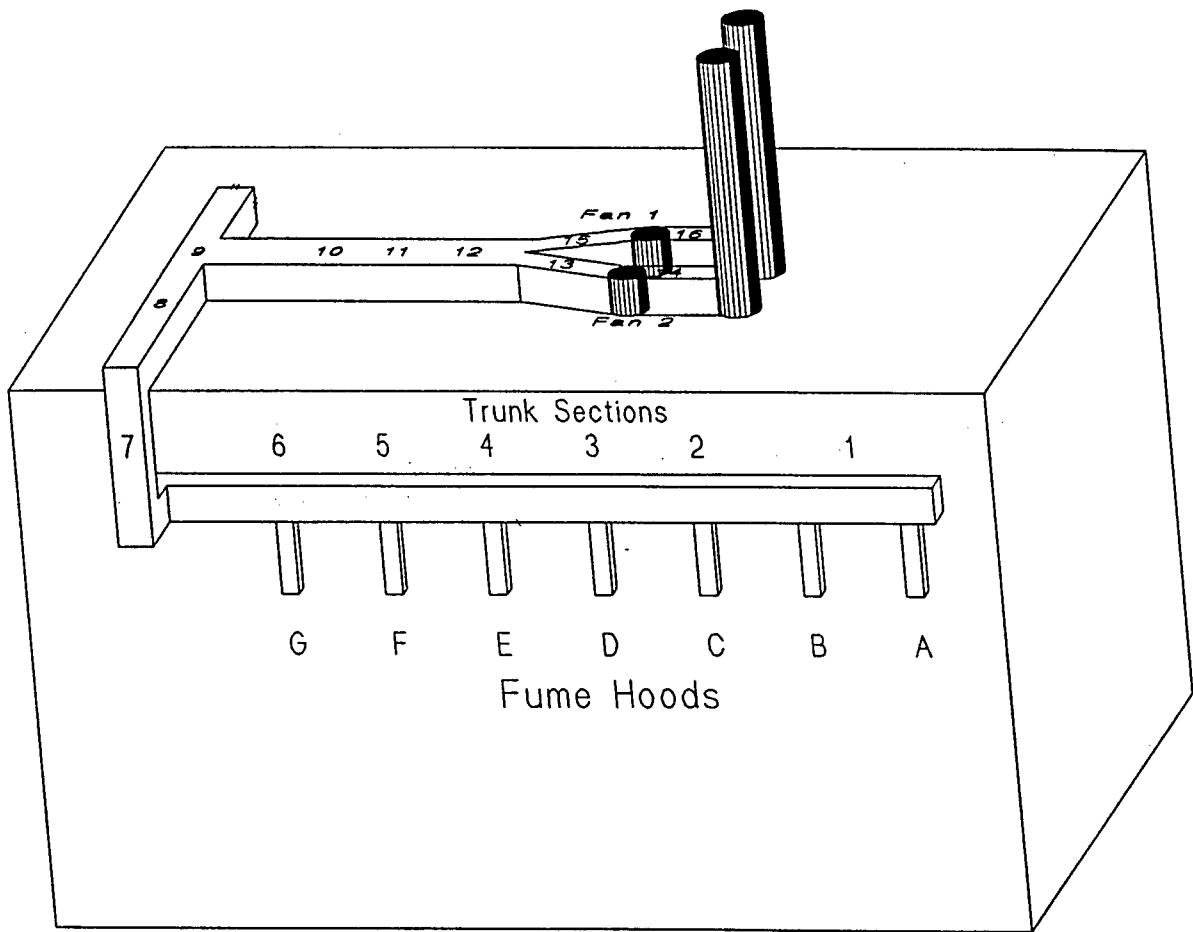
Figure 9. Schematic Of R/A Laboratory Fume Hood Trunking

Radiological contamination was detected inside the fume hood trunking leading from the fume hoods along the south side of the R/A Laboratory in the agent simulant preparation area [7]. The highest levels (up to 15 Bq/cm^2) were detected in the trunking near fume hood A (see Figure 9) with the level decreasing as the distance from fume hood A increased. No contamination was found on the vertical section of trunking leading from the fan mounted on the roof of Building 12, nor on the roof itself. In total, 18 m of trunking (surface area = 41 m^2) between fume hood A and fan No. 1 was found to be contaminated. The total activity calculated for the contaminated trunking is given [7] in Table IV. The contamination was in the form of a thick layer of dust/dirt (up to 2 cm deep) inside the trunking. Sample analysis in these and other contaminated areas (see below) indicated that Strontium-90 and its daughter product Yttrium-90 (Y^{90} , $t_{1/2} = 64 \text{ h}$) were the source of the radiological contamination.

In general, the levels of loose contamination in the fume hood trunking (up to 15 Bq/cm²) exceeded regulatory criteria.

The survey team also carried out decontamination work to remove the loose contamination from the fume hood trunking and the fixed contamination from the working surfaces of Fume Hoods A and B within the R/A Laboratory [8]. In the case of the trunking, this was accomplished by disconnecting individual sections and removing the accumulated contaminated dust in the trunking interior by dry brushing. Contaminated debris and cleaning materials were packaged and placed in appropriately labelled metal containers for subsequent removal and disposal. The working surfaces of the fume hoods were scrubbed with metal brushes and the scrapings/paint residues were also packaged for disposal in the same manner. On completion of this decontamination, only background levels of radiation were measured on the affected surfaces and no loose contamination above the detection limit of the swipe counter was detected on swipe samples. Thus, the final radiological decontamination of the R/A Laboratory had the following objectives [9]:

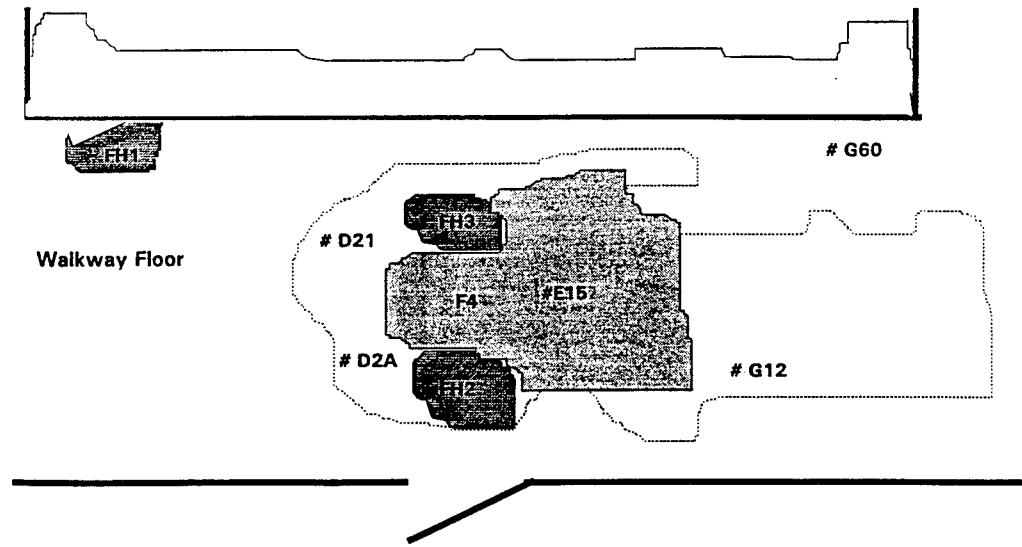
Figure 10. Distribution Of Contamination On R/A Laboratory Walkway

Approximately 10 m^2 of concrete walkway located adjacent to the exterior of the R/A Laboratory in the southernmost portion of Building 12 was found to be contaminated with Strontium-90. The distribution of the contamination was in the form of discrete "hot spots", as shown schematically in Figure 10. The level of contamination ranged from approximately 80 Bq to 1215 Bq, as measured with a Berthold Area Contamination Meter equipped with a beta/gamma tube [7].

A hole approximately 10 cm x 10 cm x 2 cm deep was chipped in the concrete at one of the strongest 'hot spots" to estimate the depth of contamination. Readings at the bottom of the hole were an order of magnitude less than the surface readings but were still at least one order of magnitude above background. These results and the contamination pattern indicated the contamination was likely caused by a spill of a Strontium-90 liquid source on the concrete which was subsequently spread along the walkway, probably by people walking through the area. The liquid had penetrated the concrete to a depth greater than 2 cm. The total amount of contamination, estimated by summing the activity in each area for the total number of areas, was approximately 300 kBq [7]. The average contamination level over the affected walkway area was 3 Bq/cm², yielding a dose rate 0.5 m above the contaminated walkway of approximately 1 μ Sv/h, which exceeded regulatory criteria.

Starting with the “hot spots”, the concrete was first chiselled to an average depth of 2 cm, followed by conducting a radiological survey. The survey results indicated that the contamination had penetrated the concrete to a greater depth. For example, contamination was detected at depths exceeding 10 cm in the FH2 area. This was attributed to the possibility that a liquid spill containing Strontium-90 had penetrated a crack which ran across the area, as shown in Figure 13. The concrete was further chiselled away and surveys repeated until the contamination levels were reduced to background levels.

The fine concrete dust produced while chiselling was carefully collected with small brushes into dust pans. Damp disposable cloths were then used to wipe the entire area in order to remove the fine dust trapped in the rough surface of the decontaminated areas. All contaminated concrete rubble, dust and cloths were packaged as contaminated waste for disposal.

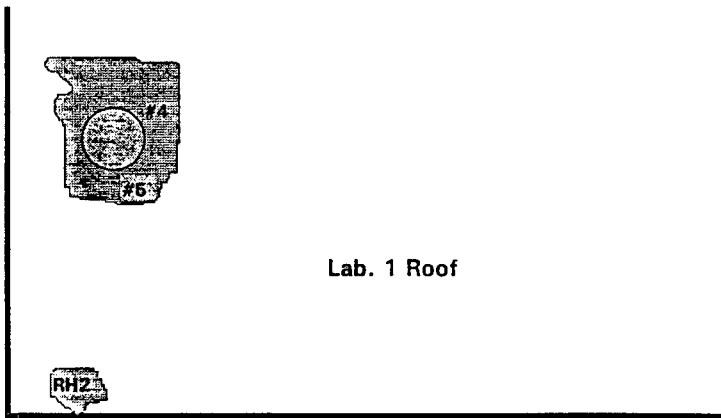
Figure 11. Distribution Of Contamination On R/A Laboratory Roof

Two separate contaminated areas, located underneath joints in the exterior fume hood trunking, were identified on the concrete roof of the R/A Laboratory vault , as shown schematically in Figure 11. The larger area encompassed approximately 1.8 m², while the smaller area covered approximately 0.12 m². Of 9 swipe samples taken in these areas, only one indicated the presence of loose contamination. This sample showed activity near the detection limit of the swipe counter and was well within regulatory limits for loose contamination.

The total activity for the larger contaminated area located under Trunk Section #9 was estimated [7] to be 2 kBq, with an average surface contamination of 0.06 Bq/cm². At a distance of 0.5 m, the corresponding dose rate was well below regulatory limits, indicating that there was no requirement to perform remedial decontamination in this case. For the smaller area located under Trunk Section #7, the total activity was estimated to be 100 Bq with an average surface contamination of 0.04 Bq/cm². The corresponding dose rate at 0.5 m was again within regulatory limits.

The concrete roof of the R/A Laboratory vault was decontaminated in the same manner as the walkway. As shown schematically in Figure 11, two separate areas located underneath the joints of the exterior fume hood trunking, designated RH1 and RH2, were identified for decontamination. As noted above, the fume hood trunking had been removed and decontaminated previously. Small dust containment huts were constructed and placed around the contaminated areas to completely isolate these areas. All decontamination work was then carried out inside these huts, as shown in Figure 14.
